Sierra Aluminum Implements Casting Pit Upgrades for Improved Billet Quality

Casting Pit Audit

Casting Pit Upgrades

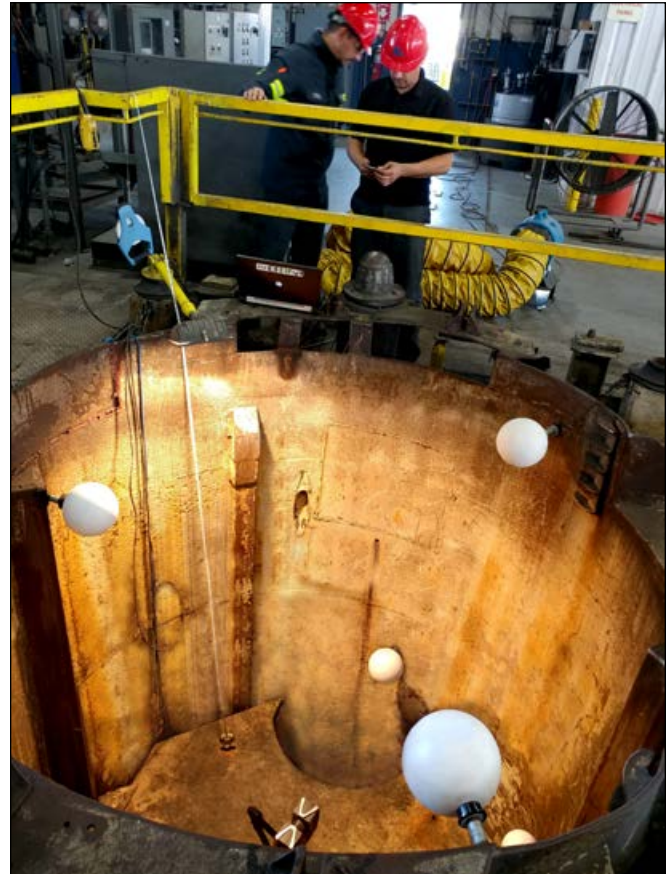
Placing the laser scanner on the platen and providing an array of reference nodes in and around the pit (Figure 1), the platen was lowered completely and then raised

Figure 1. 3D scanning of the casting pit.

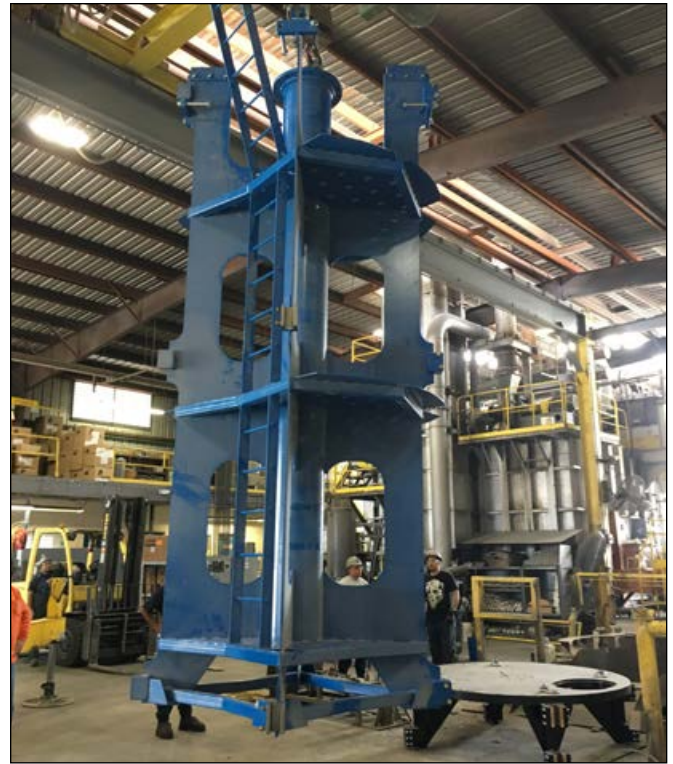
The casting pit at Sierra Aluminum is cylindrical in shape with a steel caisson providing the pit wall. Following 28 years of operation, the wall of the casting pit is no longer uniform, so a new guide rail system design needed to accommodate for these imperfections. A single use, full height jig fixture was designed by the Dynamic Concept engineers that could be installed in the casting pit and provide support and accurate location positioning for the guide rails (Figure 3). It also provided a series of working platforms for the installers to use throughout the entire casting pit without the need for temporary scaffolding (Figure 4).

Figure 3. Full height jig fixture built for casting pit.

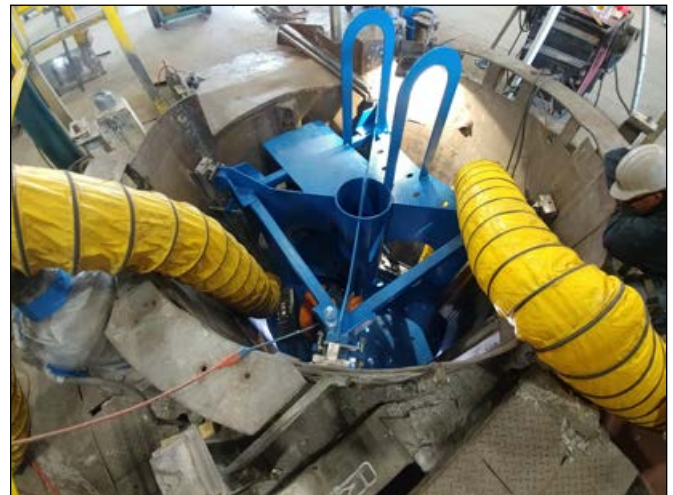
Figure 4. Installers working on the first level jig platform and the new guide rails secured in place ready for welding.

Installation: Considering the pit wall was a steel caisson, the guide rails were designed to be welded to the pit wall. The accuracy of this welding process was extremely critical and was carried out by two of the Sierra Aluminum maintenance crew with continual tolerance checks by the Dynamic Concept lead engineer. The entire team of welders, inspector, and safety observers worked diligently for three full days in safe but cramped and less than comfortable conditions to complete the work. The end result was all four rails being installed within a few

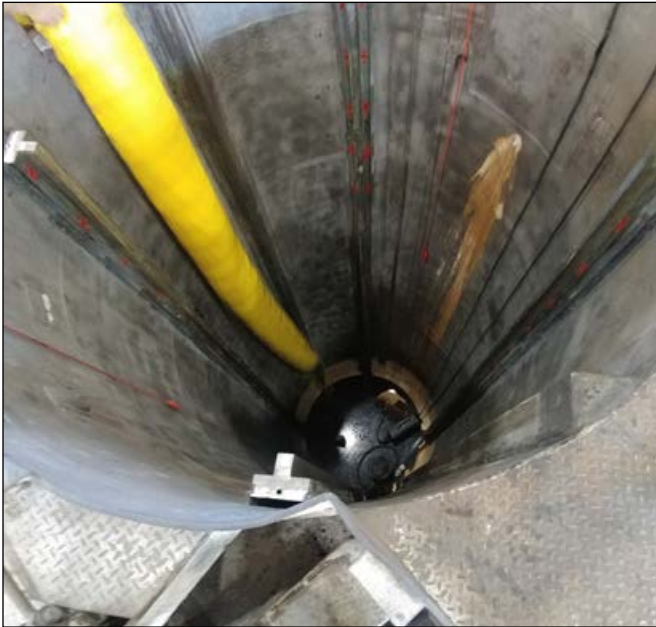
Figure 5. Guide rails and new platen installed as the pit is being prepared for painting.

Upon completion of the rail installation, the jig was removed from the pit, the new platen was installed (Figure 5), and the mating guide rail shoes adjusted. The cylinder was then put through numerous motion trials to ensure there were no hang-ups, tight spots, or interferences that could affect product quality or safe opera-
